TAKING IT EASY

Dromec, headquartered in Rhenen, Netherlands, specializes in high-performance winch development. A fishing company customer was struggling with defective gearboxes in its electric winches. The cause of the issue was a mystery. Dromec sought advice from the condition monitoring experts at Bachmann Monitoring.

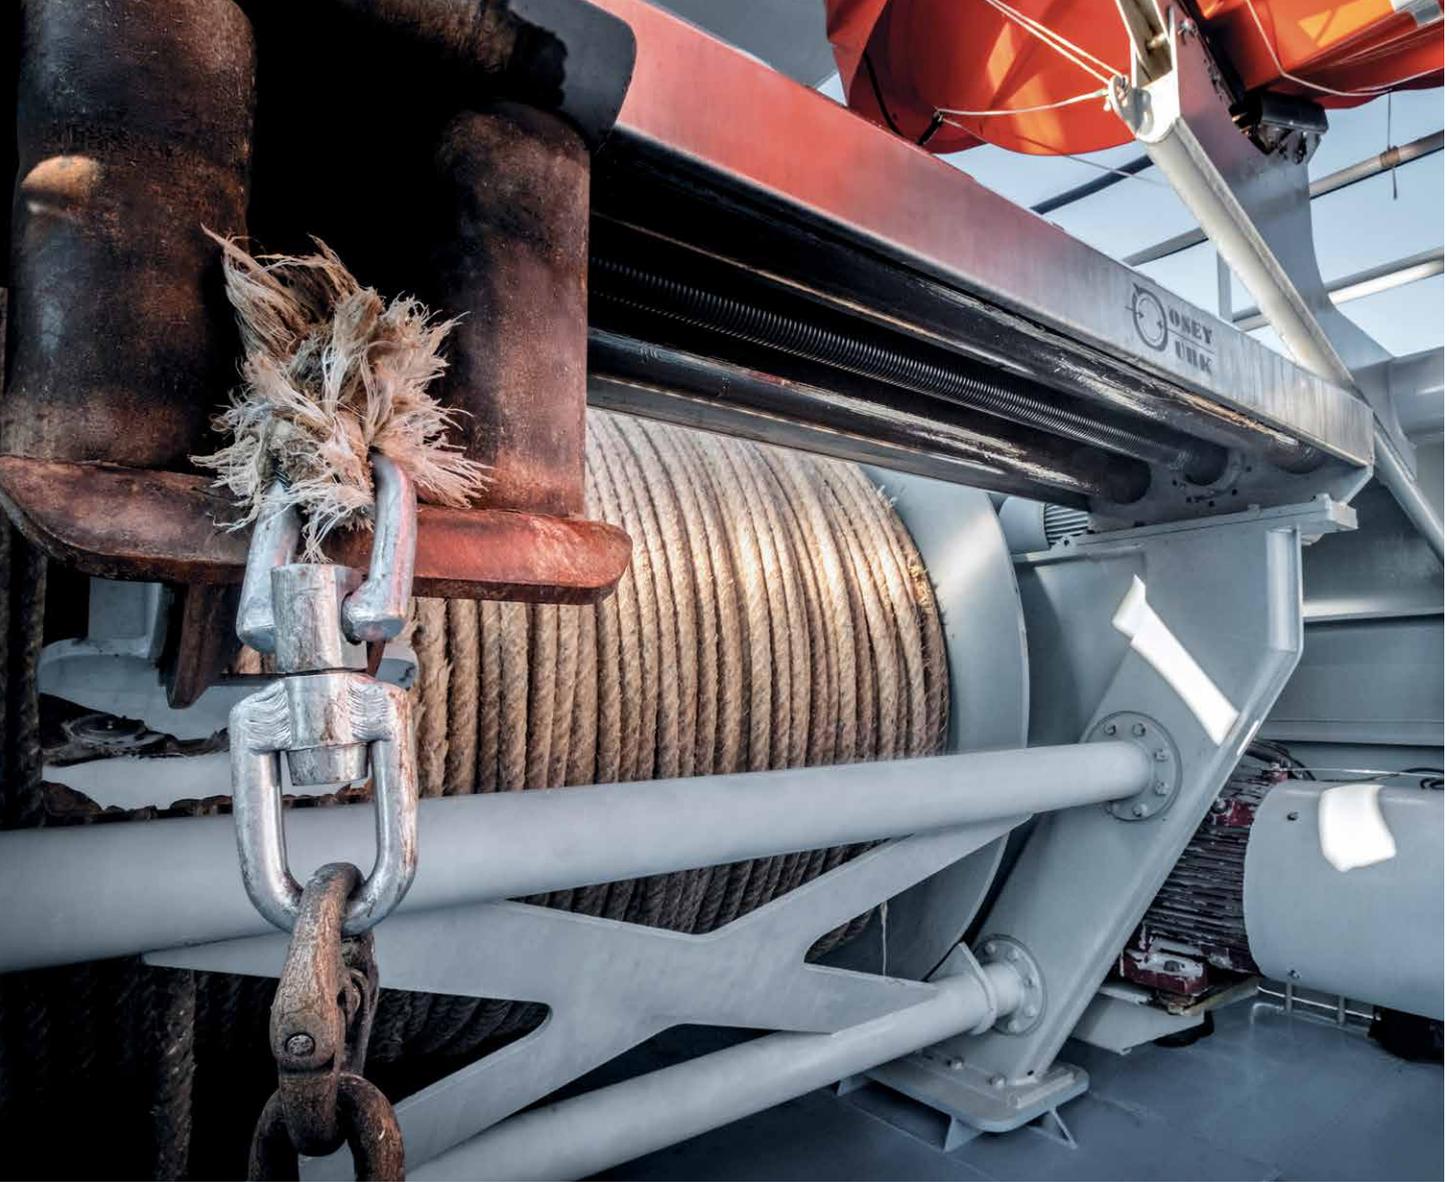
Dromec relied on Bachmann's expertise to evaluate the reasons for recurring gearbox defects in the winches of a fishing boat.

The company already experienced four defective gearboxes. To determine the cause behind the failure, Dromec temporarily installed a Bachmann M200 controller, three vibration sensors on each of the two gearboxes, and two sensors on the ship's two 200 kW electric motors. The experts at Bachmann Monitoring thoroughly analyzed and interpreted the recorded data. "The condition monitoring system provided us with a comprehensive

and precise overview of the individual components. For instance, we identified a rusted bearing on the electric motor's fan due to increasing friction, which had created a new frequency in the spectrum. This meant we could replace the bearing before it failed completely," says Geerart de Vree.
